Caveat Emptor

By Vic Syracuse, EAA Lifetime 180848

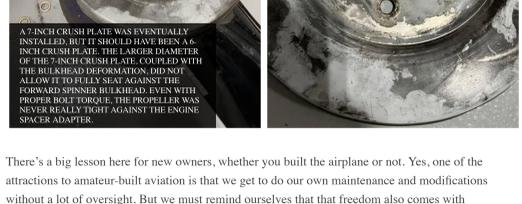
The installed crush plate for "W&B" was central to the failure. The problem here is that it was a 7-inch diameter crush plate while the propeller needed a 6-inch crush plate. This 7-inch crush plate now sat on that ridge line I mentioned, keeping it slightly above the propeller. Even with proper torque applied to the mounting bolts, there was no way this crush plate was going to fit tight against the propeller hub and properly secure the propeller to the flange. After 30 hours, it all finally let go.

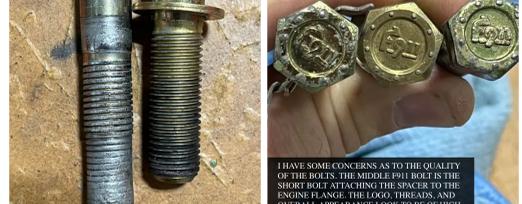
I also have some concern with the bolts that were used. They are F911 bolts, such as the ones that are used in the auto racing circuits. The shorter bolts holding the spacer to the engine flange look to be quite poorly F911 bolts. The longer propeller bolts look to be cheap, even though they are stamped high-quality F911 bolts. The longer propeller bolts is of a different color and is flaking off. There is some noise out there that bogus F911 bolts are being made in China. Propeller bolts usually have rolled threads, not cut threads. Rolled threads are up to 35 percent stronger. Look at the picture and judge for yourself.

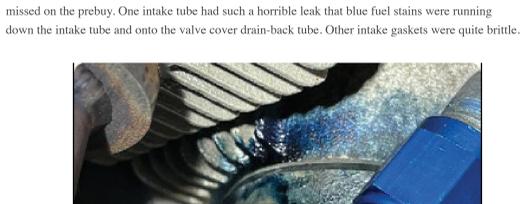
But the story doesn't end there. I also had a chance to look a little closer at the whole aircraft. It clearly isn't a showplane, but not all of them are, and there's no problem with that. It's what's under the covers that counts. In this case, some of the findings were alarming and should not have been missed on the prebuy. One intake tube had such a horrible leak that blue fuel stains were running down the intake tube and onto the valve cover drain-back tube. Other intake gaskets were quite brittle.

This one is so obvious that it really should not have been missed on the prebuy.
